Russian army uses a very rare Ladoga autonomous armored vehicle for combat operations in Ukraine

POSTED ON WEDNESDAY, 27 MARCH 2024 15:31

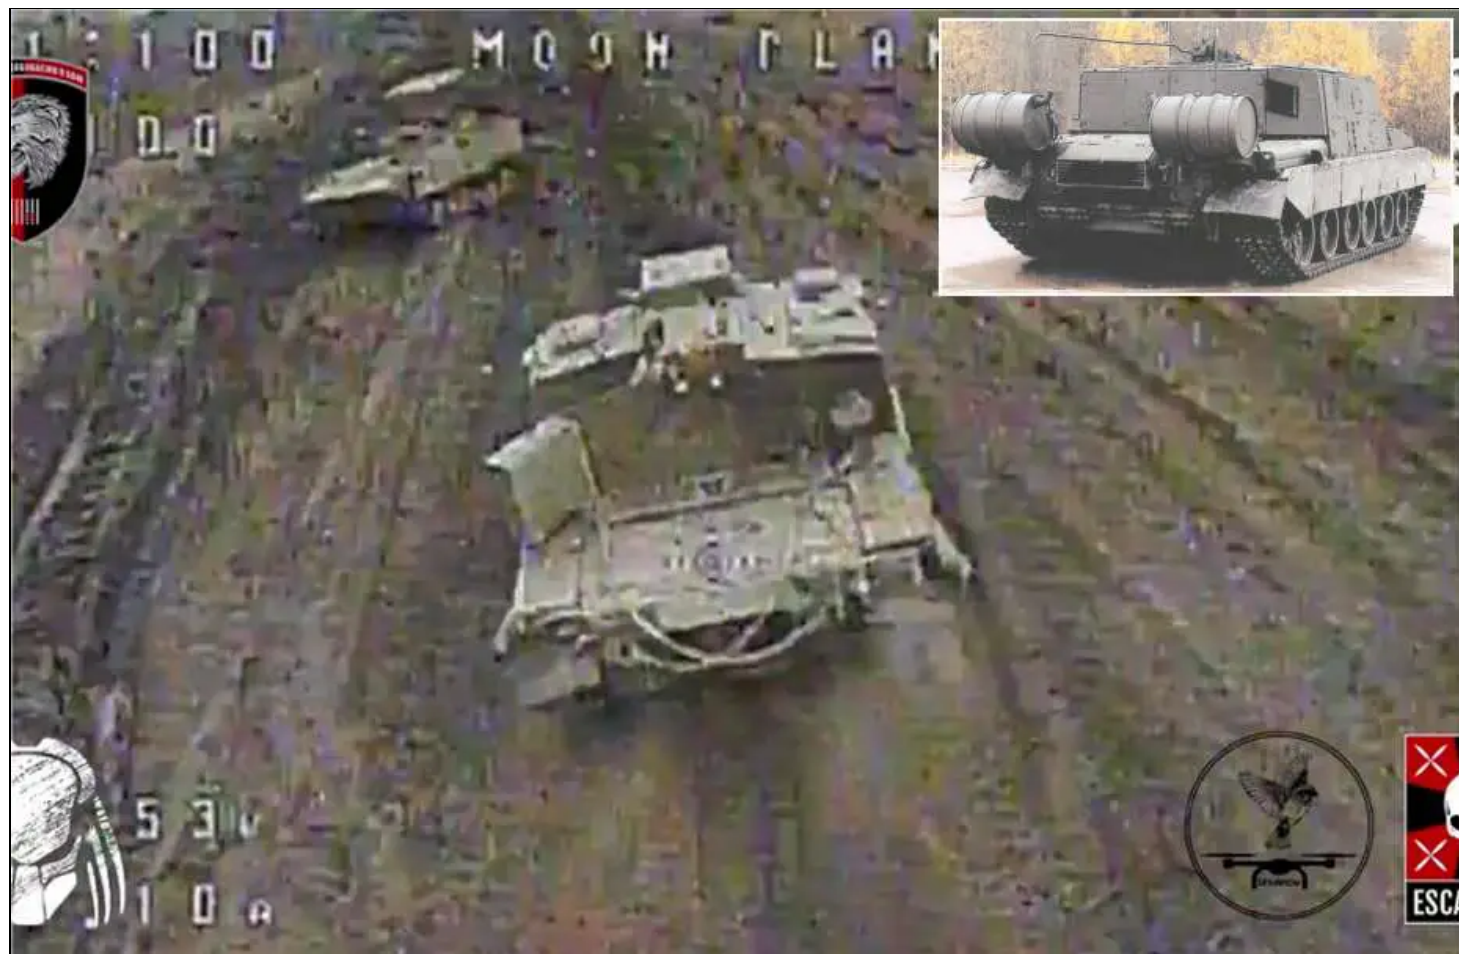
The most test of the Lagoda vehicle came during the Chernobyl nuclear disaster in 1986, where it was used to conduct reconnaissance across the radioactive environment. (Picture source: Moon Planet and Russian social media)

The Ladoga prototype underwent rigorous testing across various terrains, from deserts to mountain ranges. Its most significant operational test came during the Chernobyl nuclear disaster in 1986, where it was used to conduct reconnaissance and assess the radioactive environment following the reactor explosion. This deployment allowed for the collection of critical data, showcasing its functionality by supporting cleanup efforts in the contaminated zone. During the period between May 3 to August 9, 1986, the vehicle covered a distance of over 4,720 km within the affected area. Following this deployment, the Ladoga prototype underwent decontamination and returned to the KB-3 unit of the Leningrad Kirov Plant for further use in research and development on September 14, 1986.

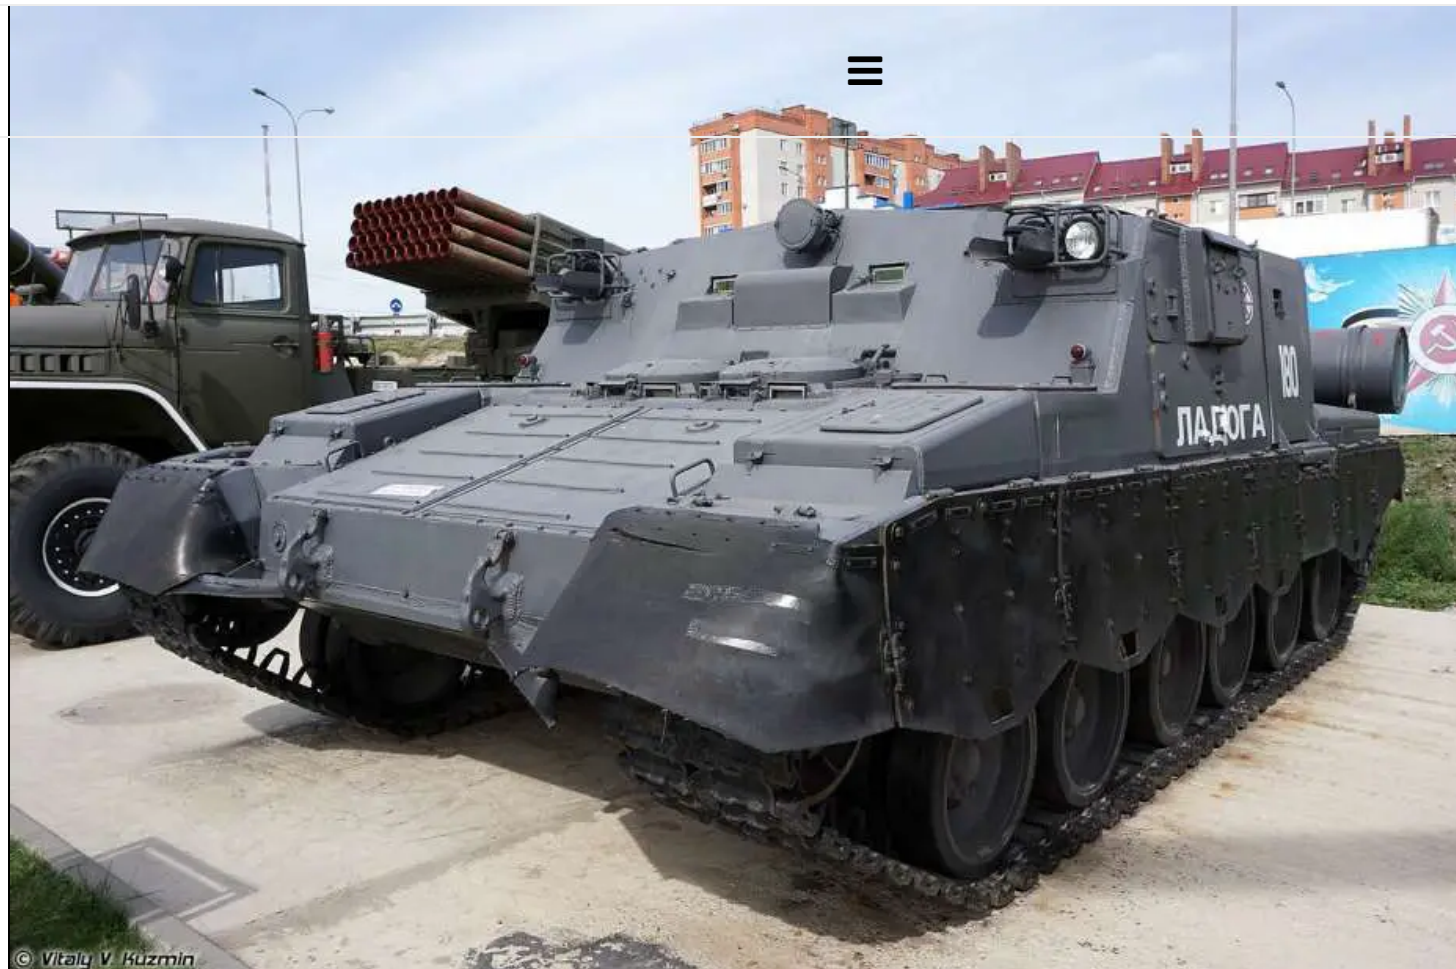
**Despite the capabilities demonstrated, the Ladoga was produced in extremely limited numbers, with estimates ranging from four to five units believed to have been manufactured throughout the 1980s.
(Picture source: Vitaly Kuzmin)**

The chassis of the T-80 tank was used as the starting point for the Ladoga, facilitating maintenance and repairs by using existing military technology, with modifications such as the removal of the turret and the incorporation of a new superstructure constructed from armored steel to house the crew and equipment. To feature an ergonomic and comfortable interior for the occupants, this superstructure features life support systems similar to those found in space exploration, including air conditioning, individual lighting, an anti-neutron lining, and advanced communications equipment to ensure that the crew can operate in sealed conditions safely and comfortably.

Internally, the Ladoga was divided into two main sections: a control compartment at the front and a main compartment for passengers, typically high-ranking officials, equipped with necessary facilities for extended operations. The vehicle is equipped with a range of communication devices, potentially including capabilities for controlling strategic nuclear forces, and surveillance equipment, including a mast with cameras for all-around visibility.
